5/17/94
I.1
LETTER REPORT
FOR
FORD MOTOR COMPANY/ALLEN PARK
ALLEN PARK, WAYNE COUNTY, MICHIGAN
TDD# T05-9404-027
PAN: EMI0249RAA
DOCUMENT CONTROL NO.: TAT-05-25-04060

Re: Ford Motor Company/Allen Park
Allen Park, Wayne County, Michigan
TDD # T05-9404-027
PAN EMI0249RAA

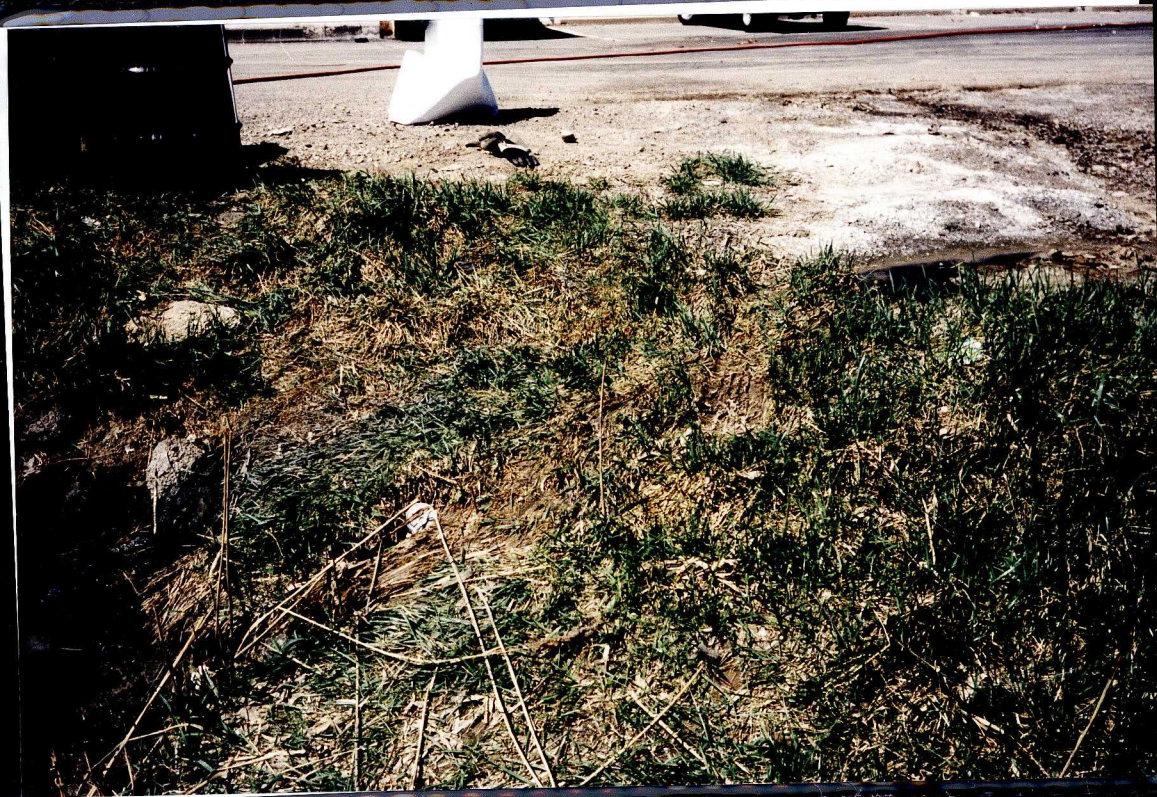
Site: Ford/Allen Park
Photo No: 1
Direction: North
Camera: Olympus 35mm

Date: 4/20/94
Photographer: Langer
Subject: Stained soils where
contamination material flowed
over soils into Reek Drain

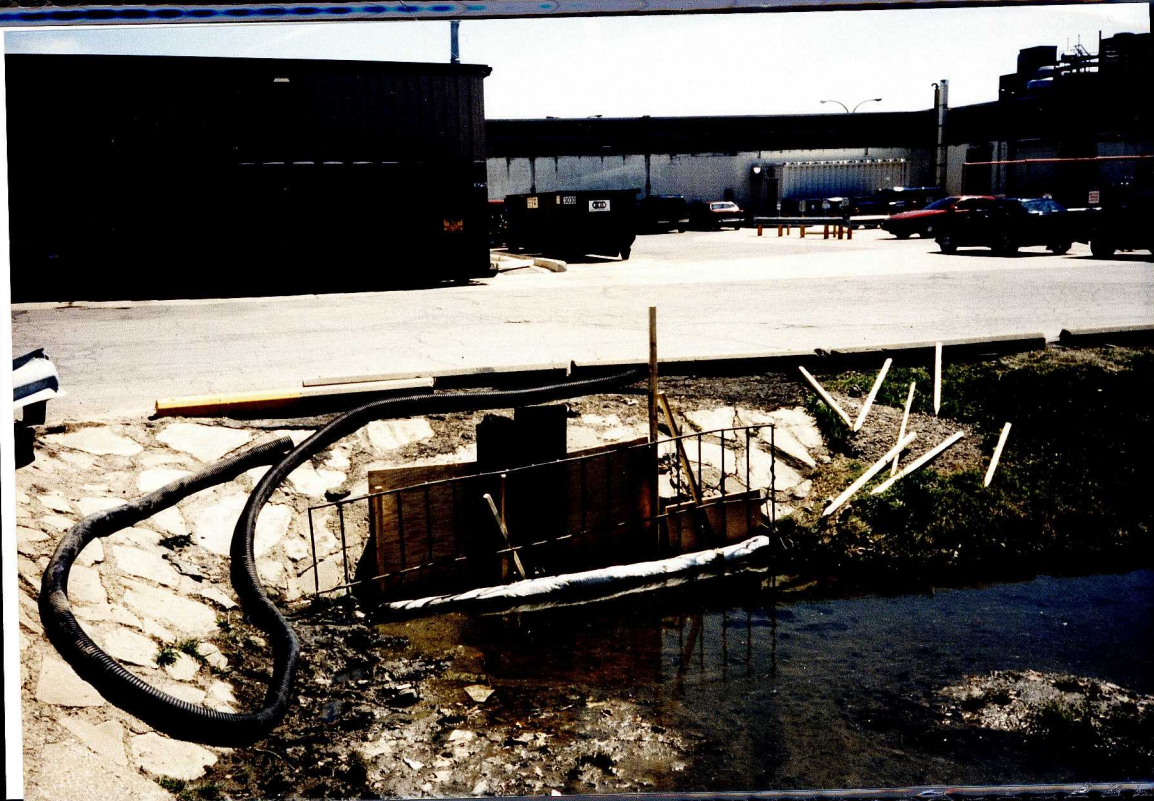
Site: Ford/Allen Park
Photo No: 2
Direction: East
Camera: Olympus 35mm

Date: 4/20/94
Photographer: Langer
Subject: Original diking to
slow water flowing into
contaminated area.

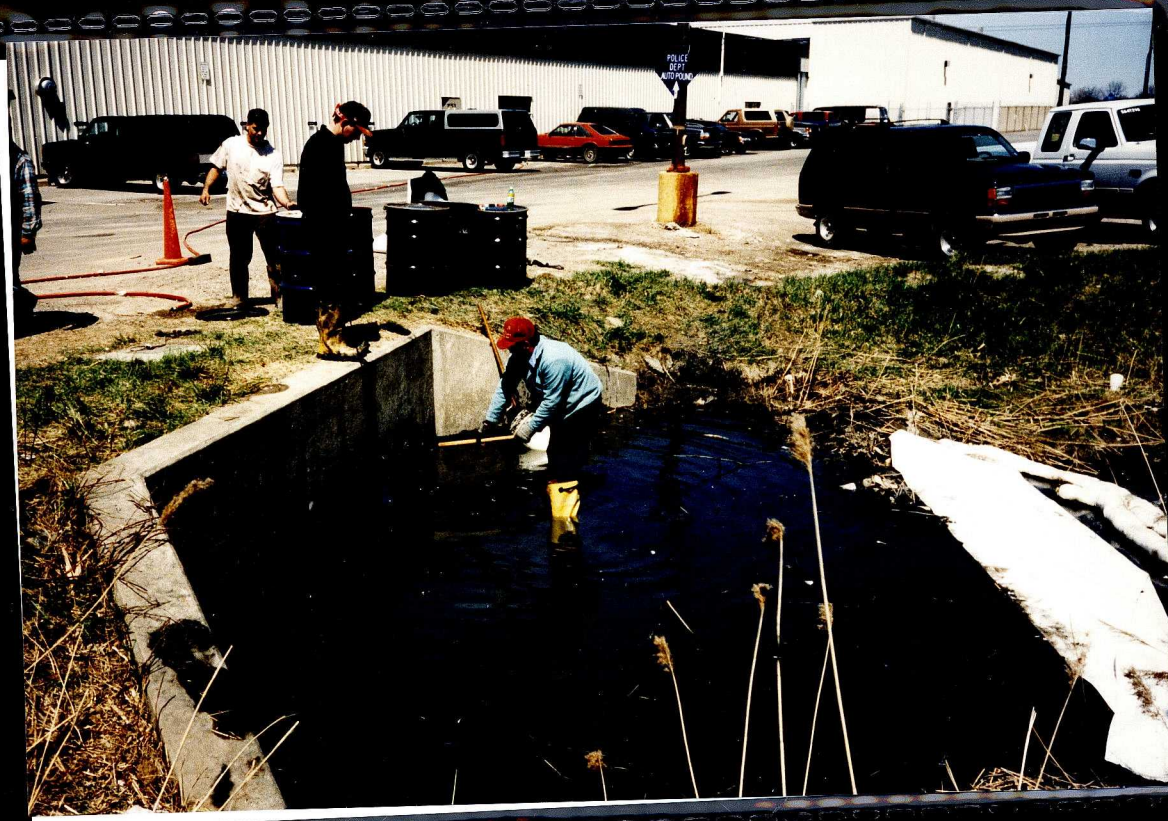
Site: Ford/Allen Park
 Photo No: 3
 Direction: North
 Camera: Olympus 35mm

Date: 4/20/94
 Photographer: Langer
 Subject: Vac-All worker
 digging out contaminated
 sediment from the Reeck Drain.

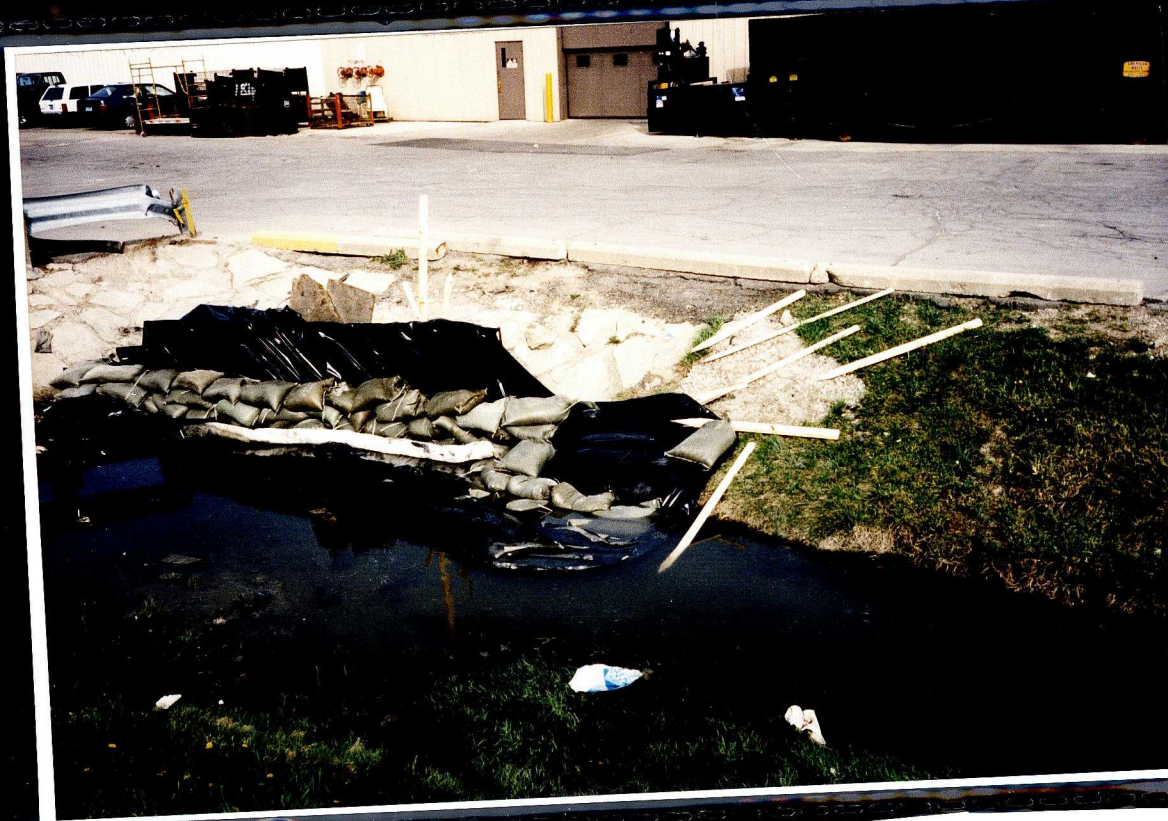
Site: Ford/Allen Park
 Photo No: 4
 Direction: West
 Camera: Olympus 35mm

Date: 4/20/94
 Photographer: Sugarman
 Subject: New dike placed to
 prevent all water flow into the
 contaminated area.

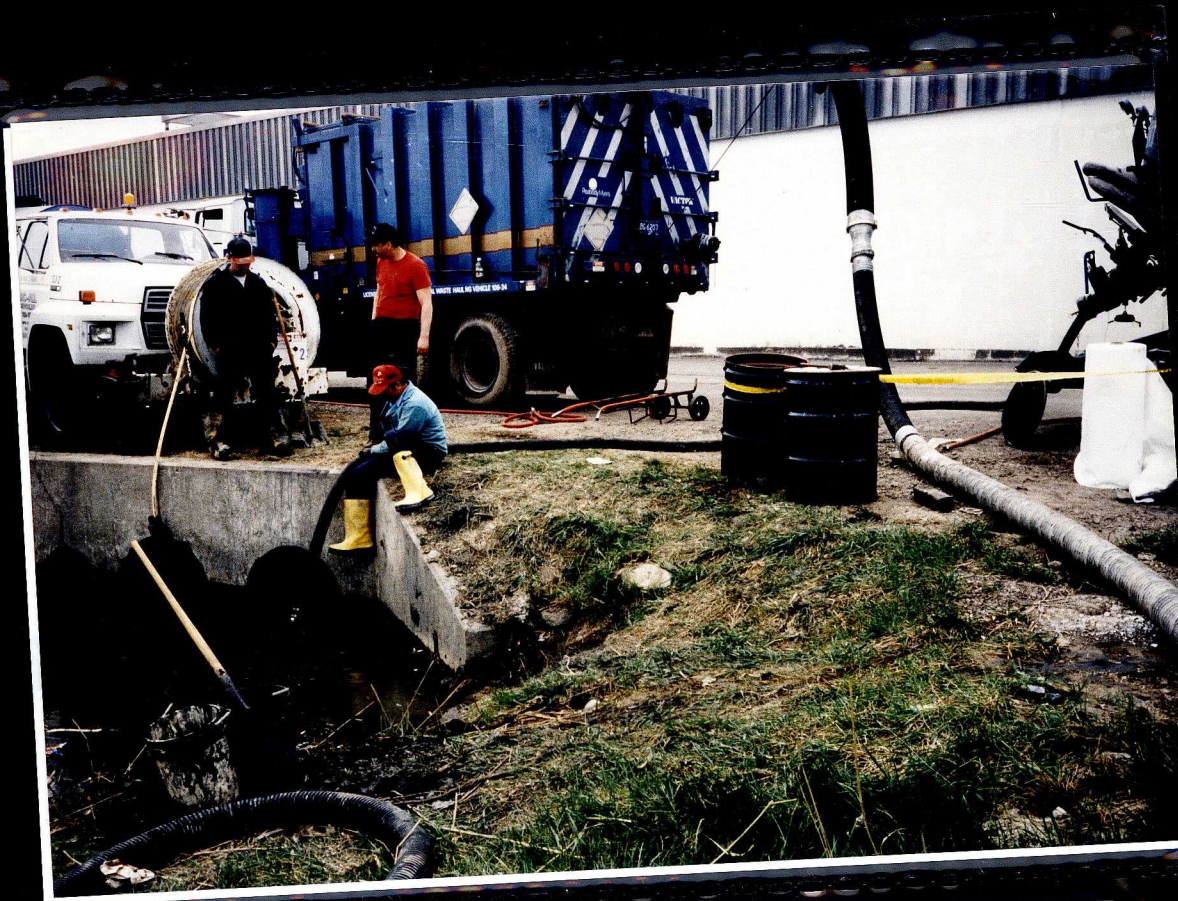
Site: Ford/Allen Park
 Photo No: 5
 Direction: East
 Camera: Olympus 35mm

Date: 4/20/94
 Photographer: Sugarman
 Subject: Water being pumped
 out of contaminated area so
 that sediments can be removed.

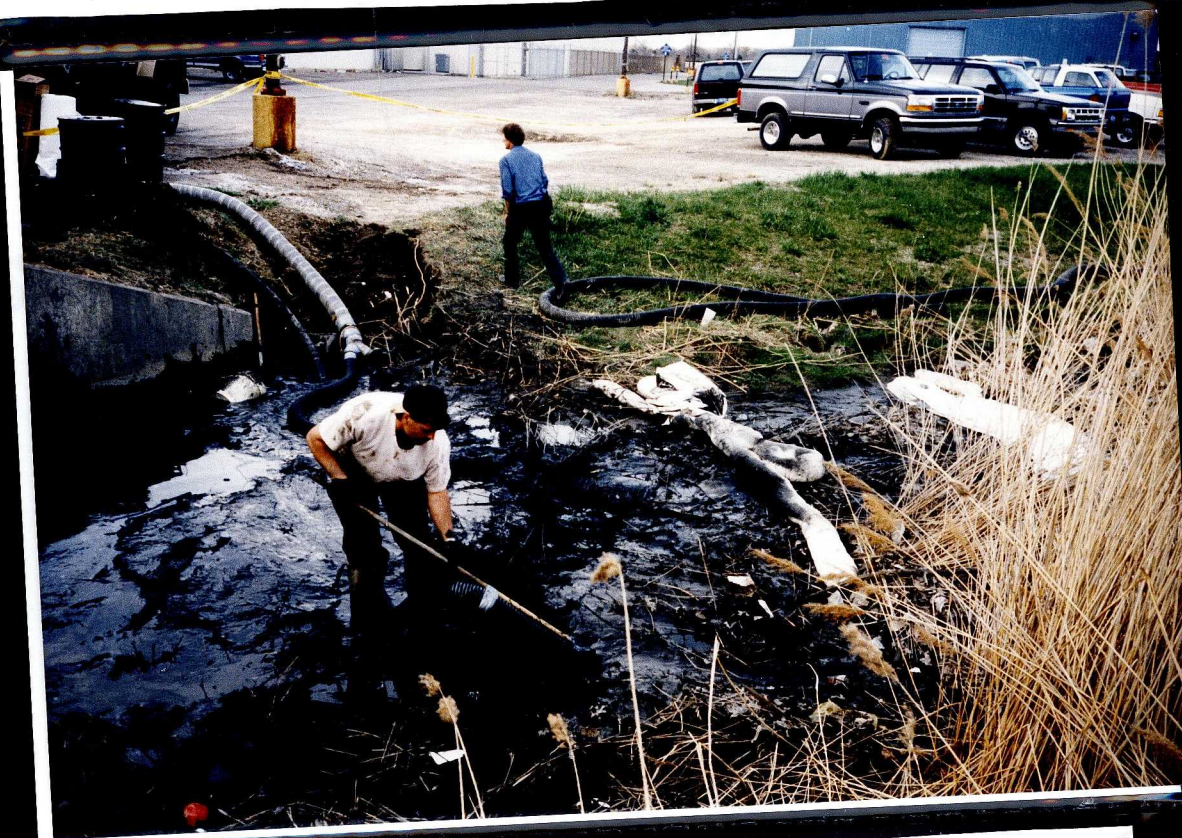
Site: Ford/Allen Park
 Photo No: 6
 Direction: North
 Camera: Olympus 35mm

Date: 4/20/94
 Photographer: Sugarman
 Subject: Contaminated
 sediments being pumped out
 using the solids vac-truck.

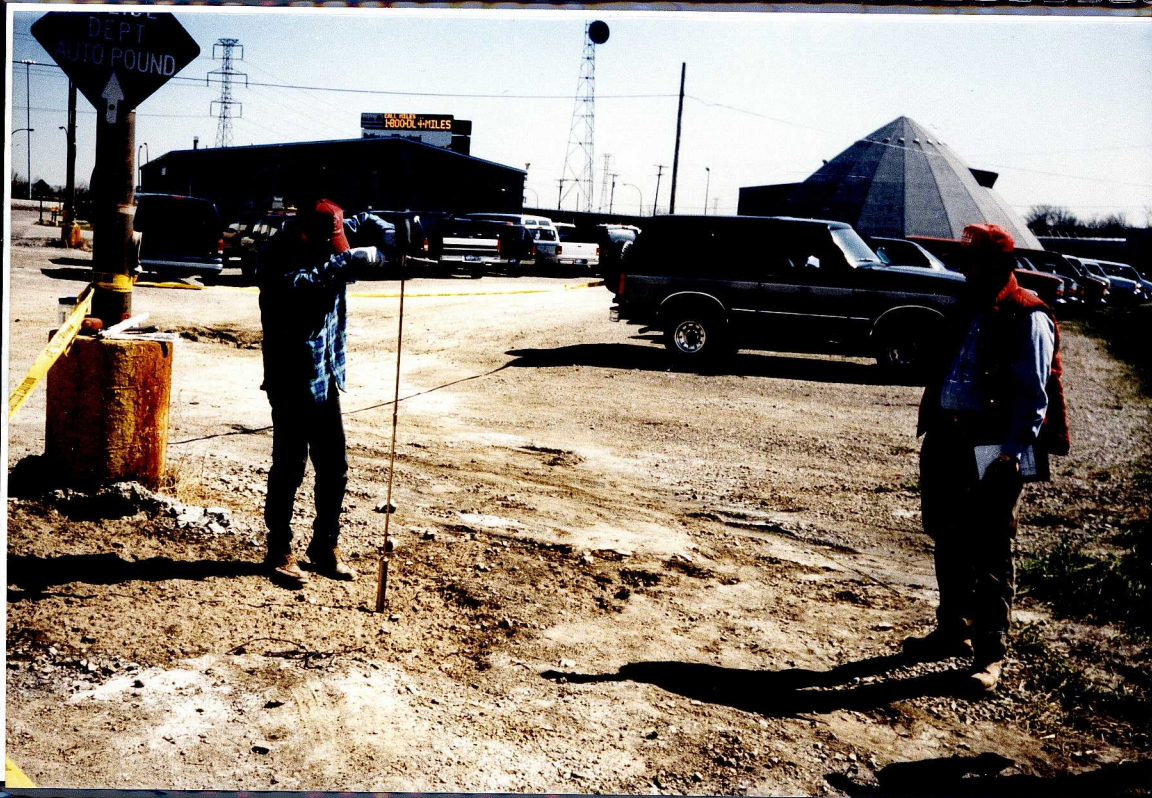
Site: Ford/Allen Park
 Photo No: 7
 Direction: East
 Camera: Olympus 35mm

Date: 4/21/94
 Photographer: Sugarman
 Subject: Envotech personnel
 collecting samples of the
 contaminated soils.

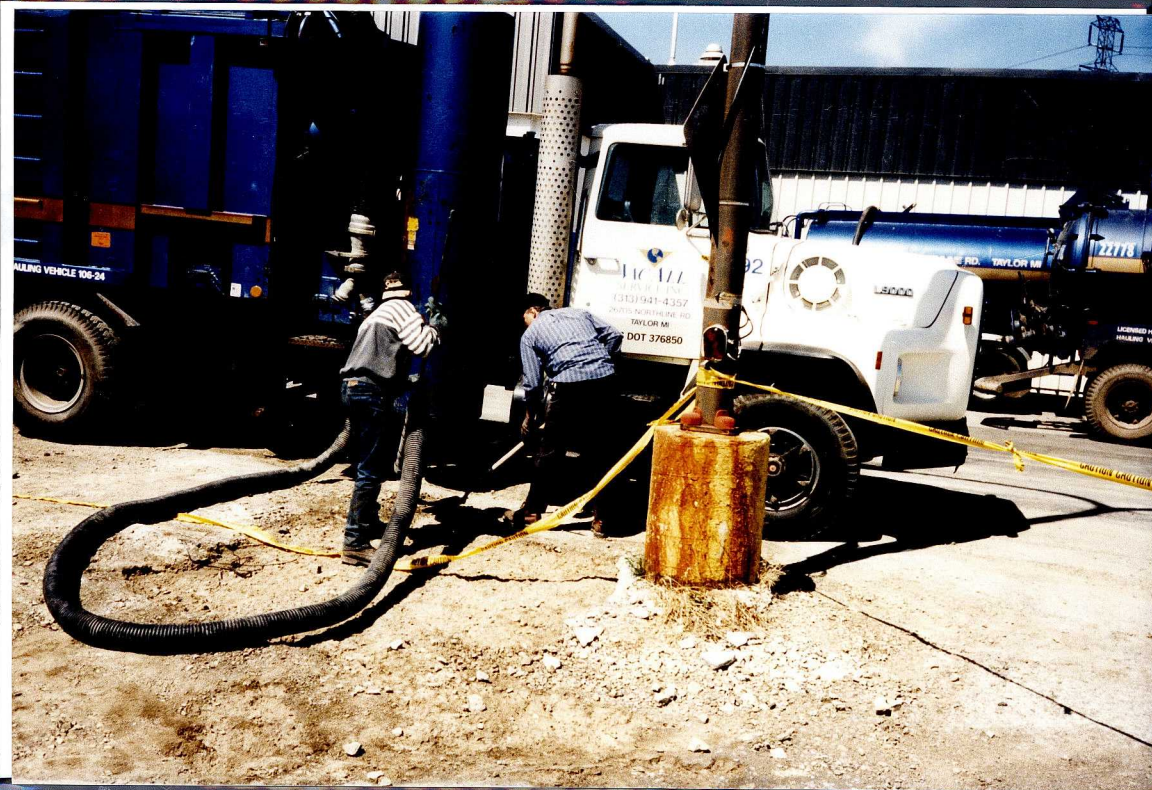
Site: Ford/Allen Park
 Photo No: 8
 Direction: West
 Camera: Olympus 35mm

Date: 4/21/94
 Photographer: Sugarman
 Subject: Contaminated soils
 being collected using the
 solids vac-truck.

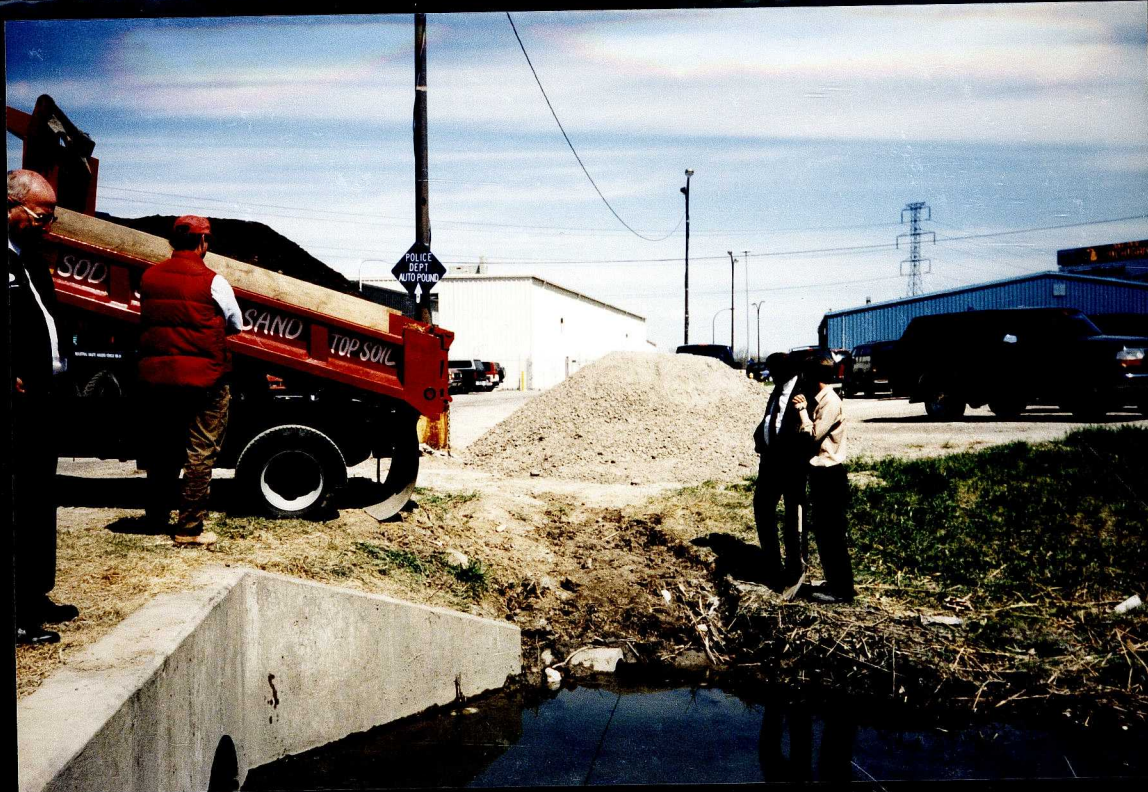
Site: Ford/Allen Park
 Photo No: 9
 Direction: East
 Camera: Olympus 35mm

Date: 4/21/94
 Photographer: Sugarman
 Subject: Topsoil and sand
 brought to replace soils and
 sediments removed for disposal.

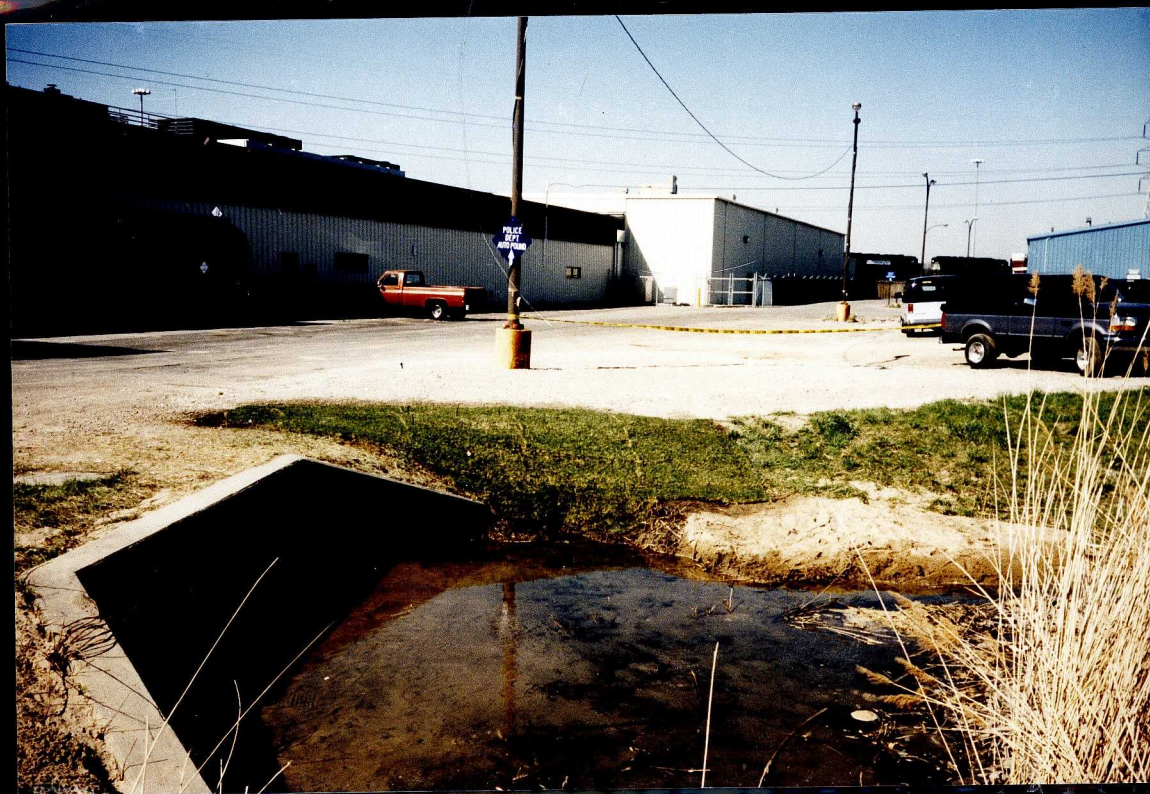
Site: Ford/Allen Park
 Photo No: 10
 Direction: North
 Camera: Olympus 35mm

Date: 4/22/94
 Photographer: Sugarman
 Subject: Contamination area after
 replacement of sediment, top soil, and
 sod.
